**CALIFORNIA REGIONAL WATER QUALITY CONTROL BOARD - SAN DIEGO REGION
WATERSHED MANAGEMENT PROGRAM**

FACILITY INSPECTION REPORT

Sprinter Rail Project

FACILITY: North County Transit District Sprinter Rail (WDID) 9 37C322900 INSPECTION DATE: 11/30/07

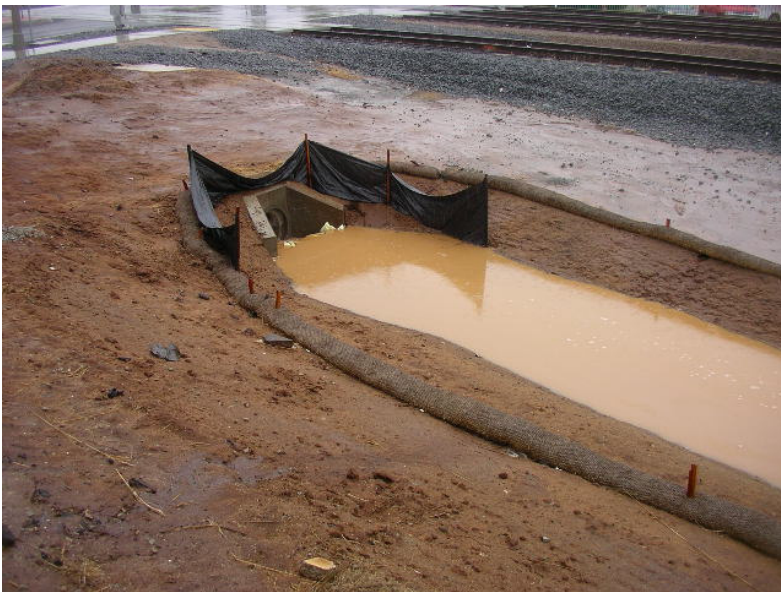
670. The sediment laden water pours into this inlet with inadequate sediment control protection. This deficiency was also noted on Tuesday, November 27, 2007.

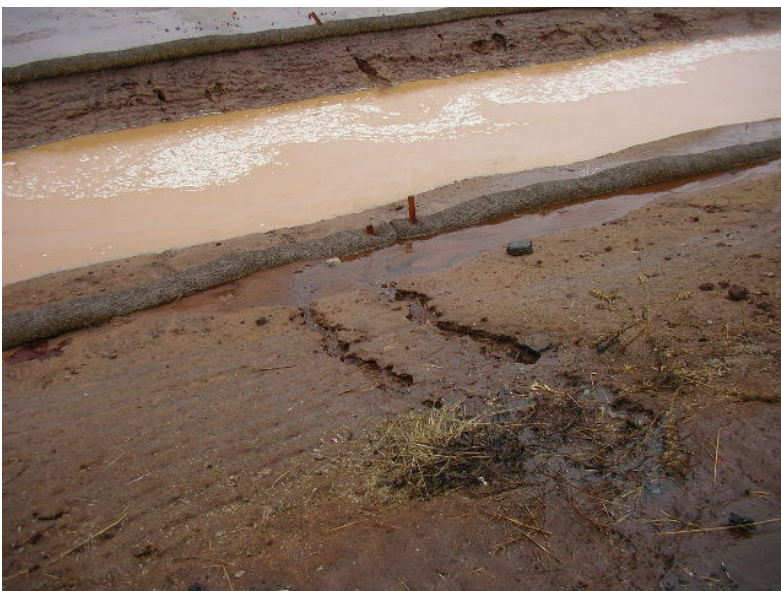
671. Slope erosion from offsite runoff not being addressed.

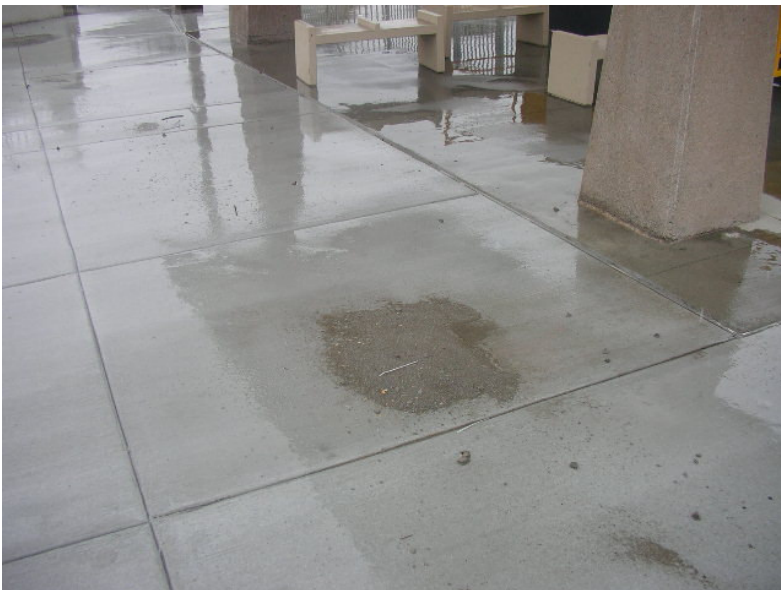
2. Coast Highway Station, Oceanside - Piles of concrete grindings remained on the station platform from the previous inspection on November 27, 2007 (Photo 676). The station platform's storm drain inlet was protected and functioning well (Photo 677). To the west of the station platform and north of the tracks, an unlined bare dirt channel was full of sediment-laden water (Photo 678). Fiber roll was ineffective due to the level of water in the channel. The dirt channel leads to a storm drain inlet that was backed up and clear water was bubbling out (Photo 679). Although the banks had previously been sprayed with an erosion control binder, storm water runoff from the top of the slope caused erosion gullies down the bank side (Photos 680, and 681). A soil stockpile was not covered but did have a fiber roll. A dirt construction entrance/exit did not have gravel to prevent sediment tracking, but no sediment tracking was noted because it had been swept up earlier (Photo 683). The tracks here form a Y shaped intersection with tracks running north, south and east. In the middle of this Y intersection lies a storm drain inlet without adequate protections that was receiving sediment laden discharge (Photos 684 and 685). The area around the inlet was without any soil stabilization. On the southwest of the Y intersection slopes were without any erosion control or soil stabilization. Large erosion gullies were present on the slope exposing the underground utilities (Photos 686, 688, and 689). To the southeast of this Y intersection, another storm drain inlet was receiving sediment laden discharge from the unlined dirt channel. The water was clear but as it flowed through the dirt channel the storm water became cloudy, turbid and full of sediment (Photos 689, 690, 691, and 693). At this point, a digital movie (file name IMG1692.mov) was taken of the discharge and is incorporated by reference into this inspection report. The digital movie file is available upon request.

676. Piles of concrete grindings are not cleaned up and left exposed on the station platform. This deficiency was also noted on Tuesday, November 27, 2007.

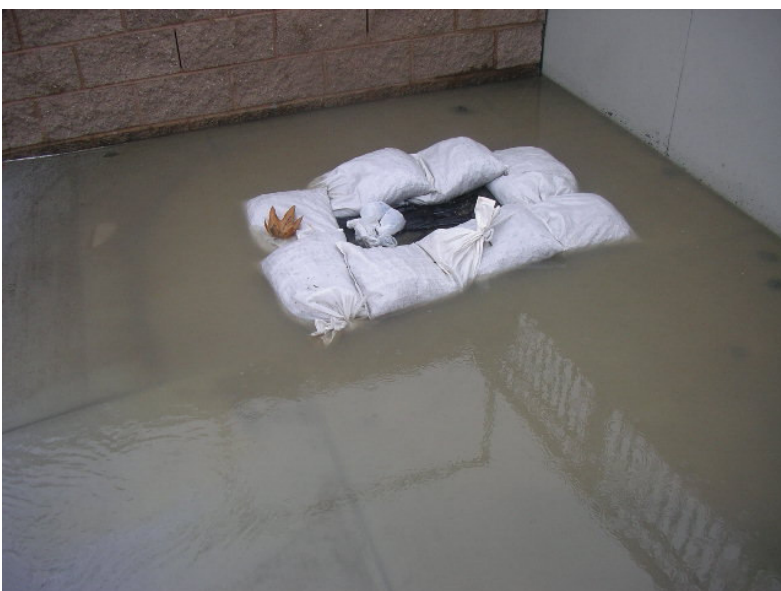
677. Station platform inlet has been protected. This inlet was previously not protected on Tuesday, November 27, 2007.

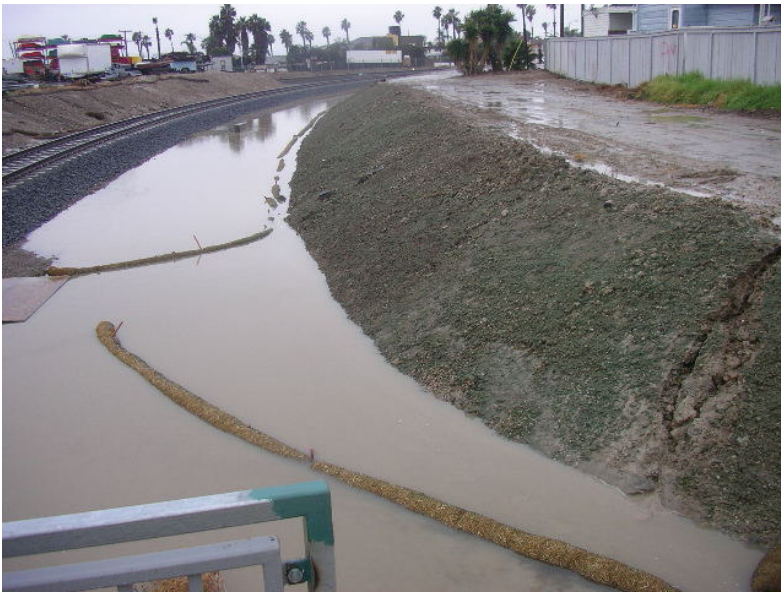
678. Unlined dirt channel is backed up with sediment laden water. Slope has been sprayed with erosion control but erosion gullies are present from concentrated flows. Fiber roll is ineffective.

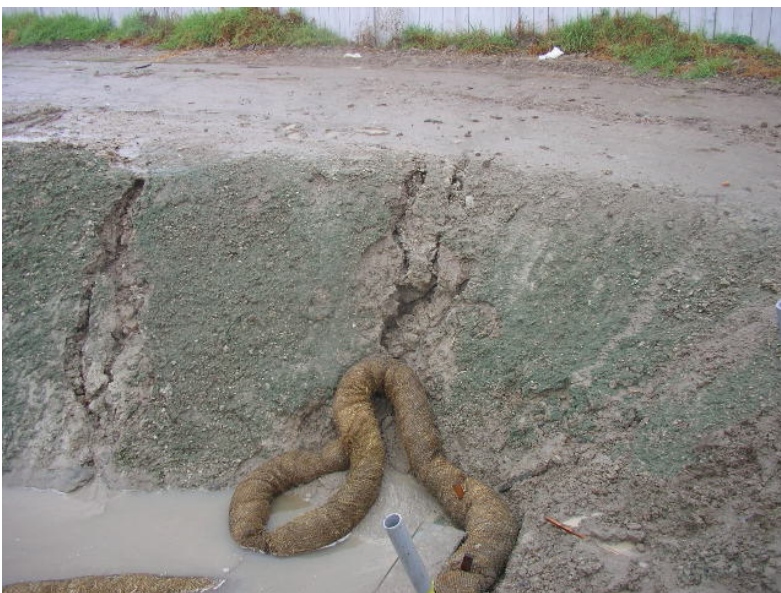
680. A closer look at erosion gullies on the slope in photo 678.

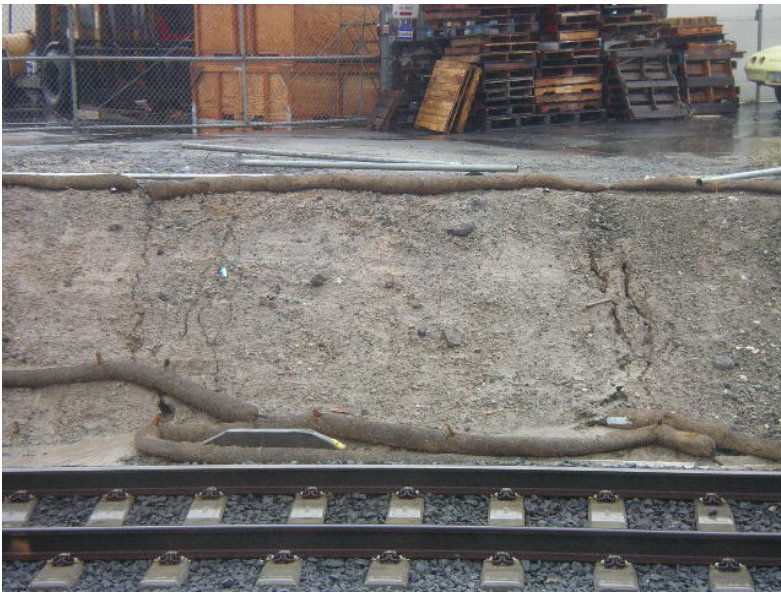
681. Erosion gullies are present on a slope.

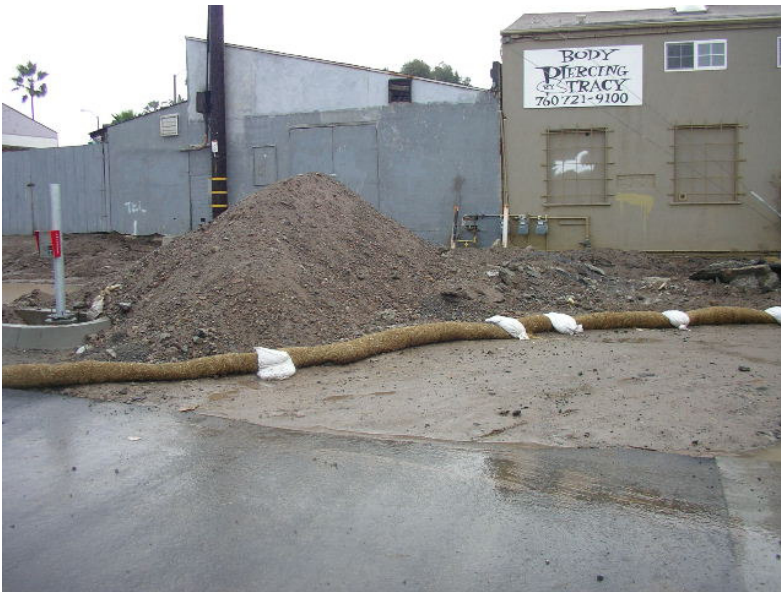
683. Stockpile has a fiber roll around it. Construction exit does not have BMPs to prevent sediment tracking. These deficiencies were also noted on Tuesday, November 27, 2007. Sediment on the pavement has since been swept up.

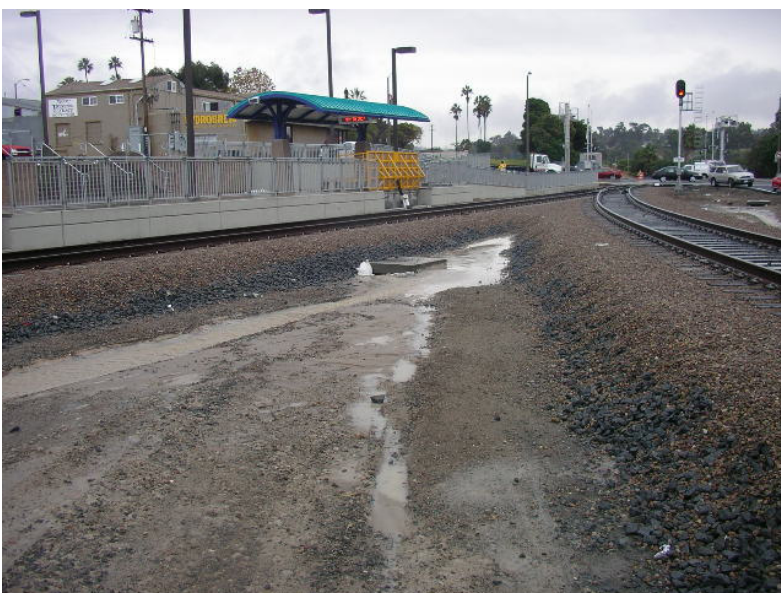
684. A storm drain inlet without adequate protection is receiving a sediment laden water discharge.

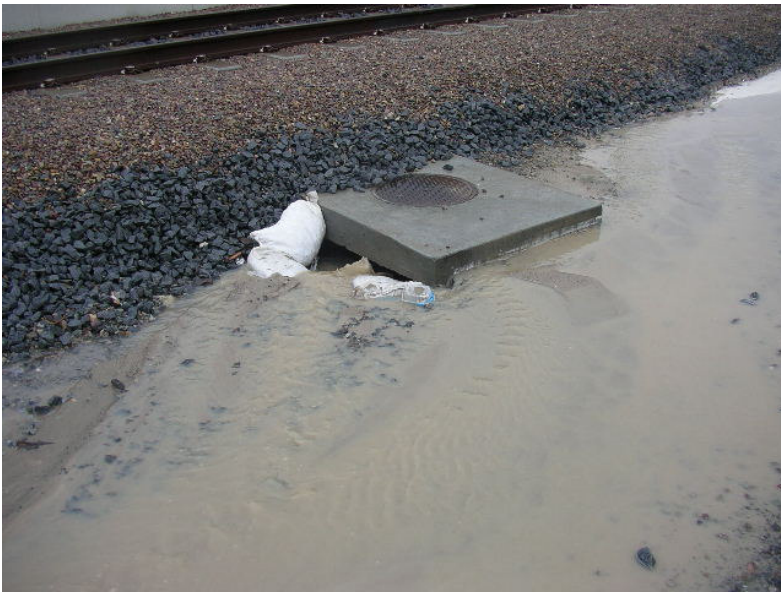
685. A closer look at the storm drain inlet in photo 684.

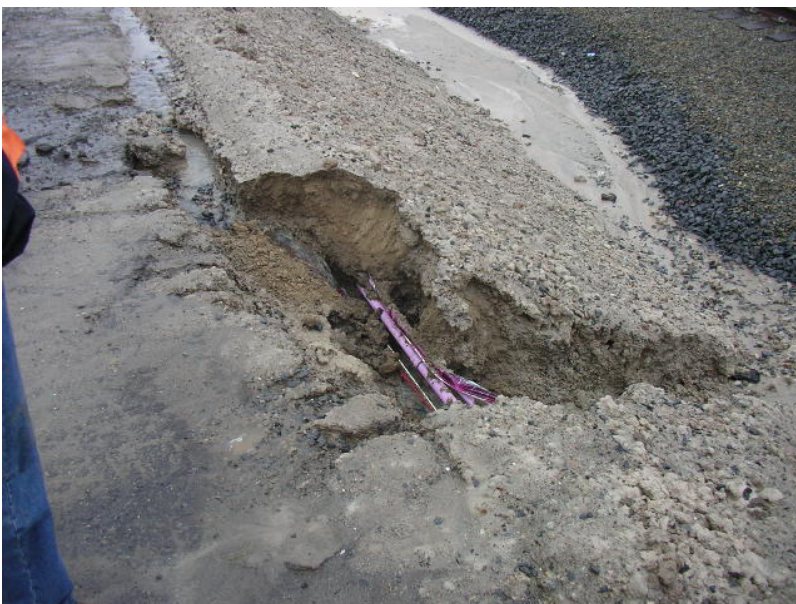
688. A closer look at one of the erosion gullies in photo 686 shows exposed irrigation pipes.

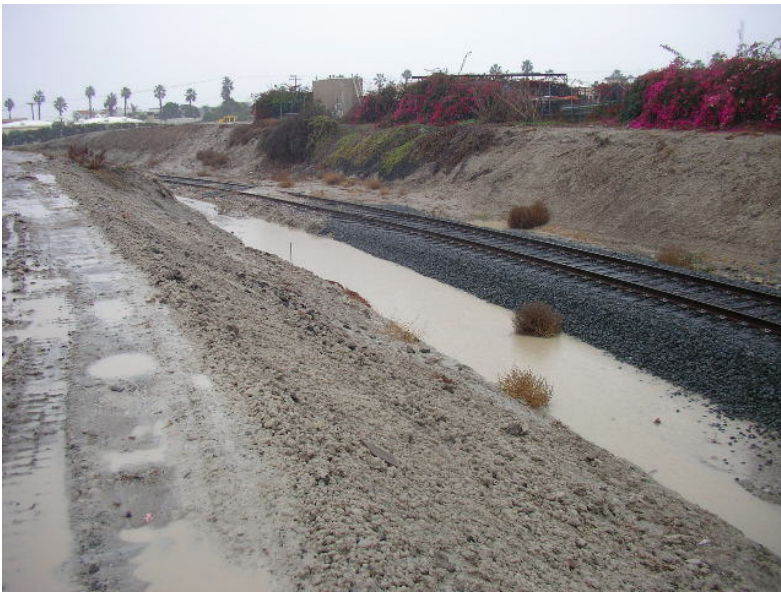
689. This photo shows where construction ended. The far slope is vegetated and the rail ballast rock is a different color. The slopes have no erosion or sediment controls.

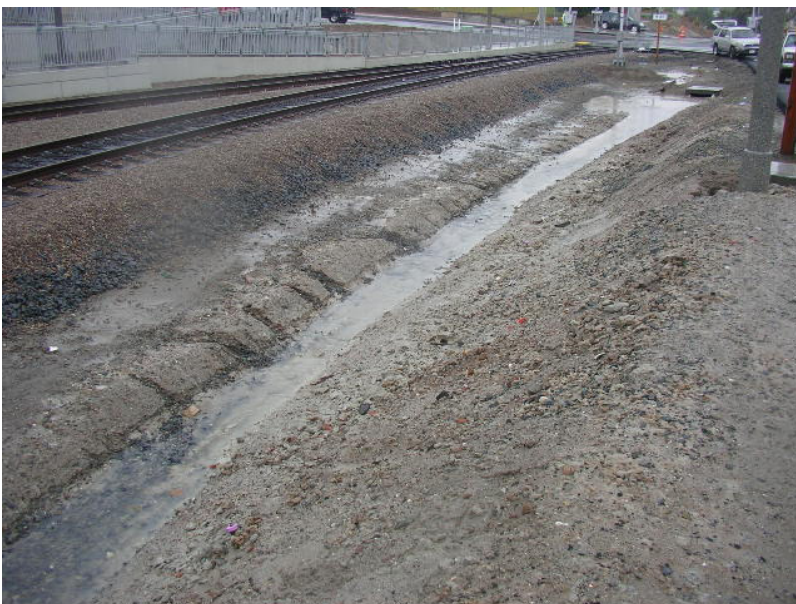
691. The same dirt channel in the previous photo leads to the far storm drain inlet.

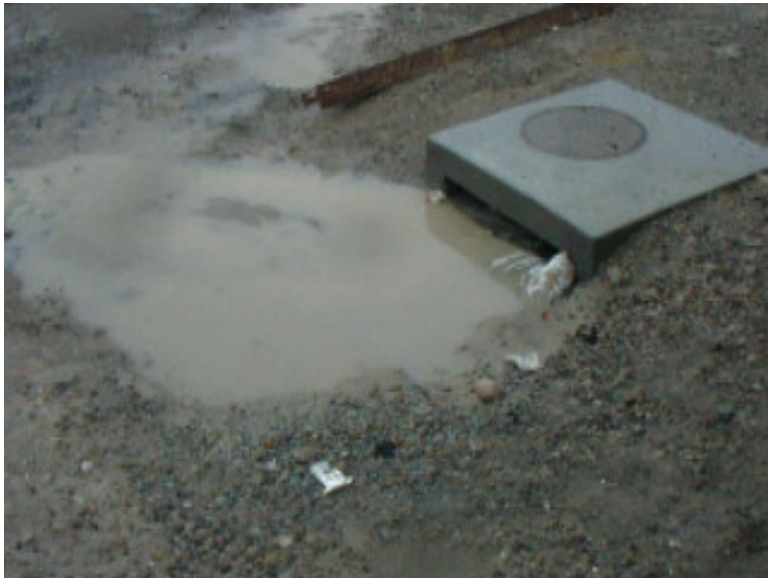
692.mov Screen shot from a movie showing the sediment laden water in photos 690 and 691 entering a storm drain with inadequate protection.

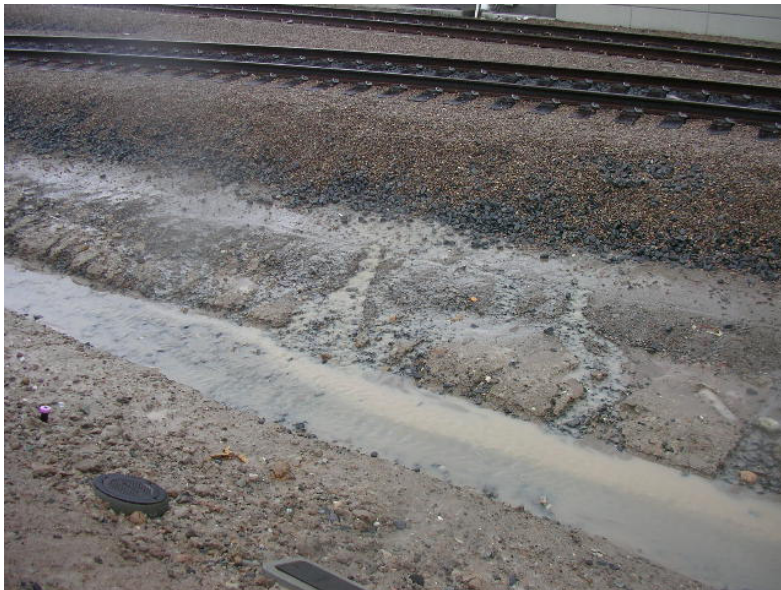
693. Another look at photos 690 and 691 shows the clear water on the left and the plume of sediment laden water on the right.

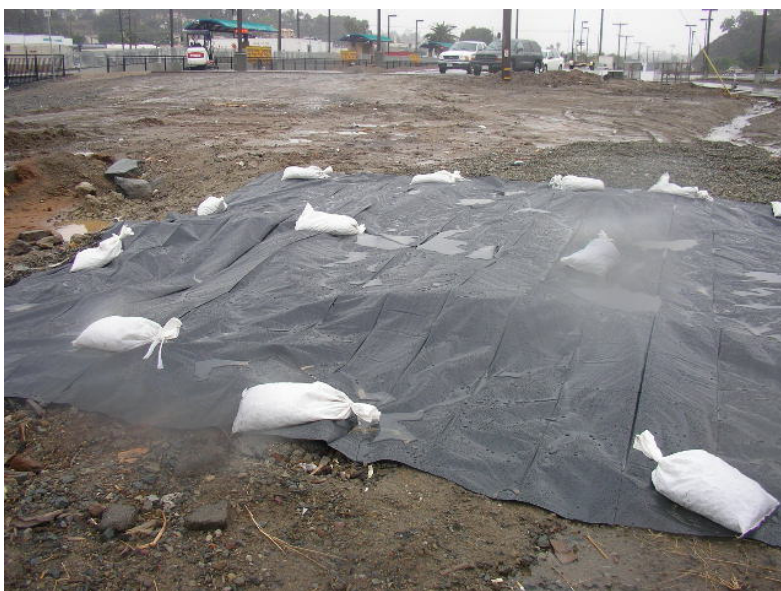
694. Remnants of an asphalt cold mix stockpile have been covered with plastic. This was in response to a deficiency noted on Tuesday, November 27, 2007.

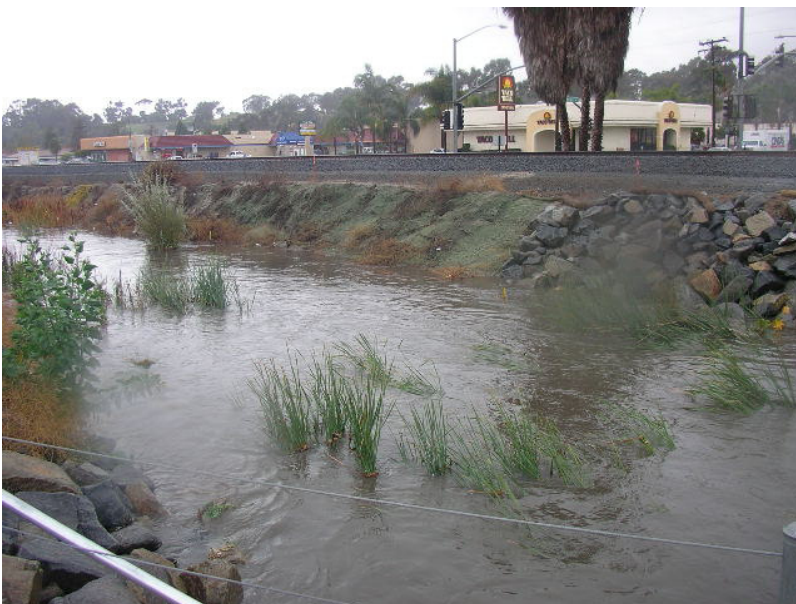
698. The far slope has been sprayed with erosion control. This was subsequent to deficiencies noted on Tuesday Nov. 27, 2007.

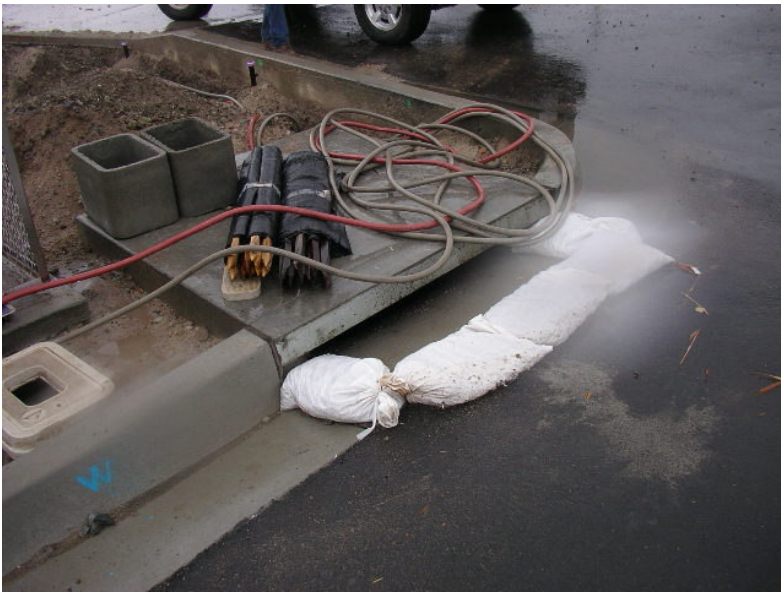
699. Storm drain inlet has been protected. This was in response to deficiencies noted on Tuesday, November 27, 2007.

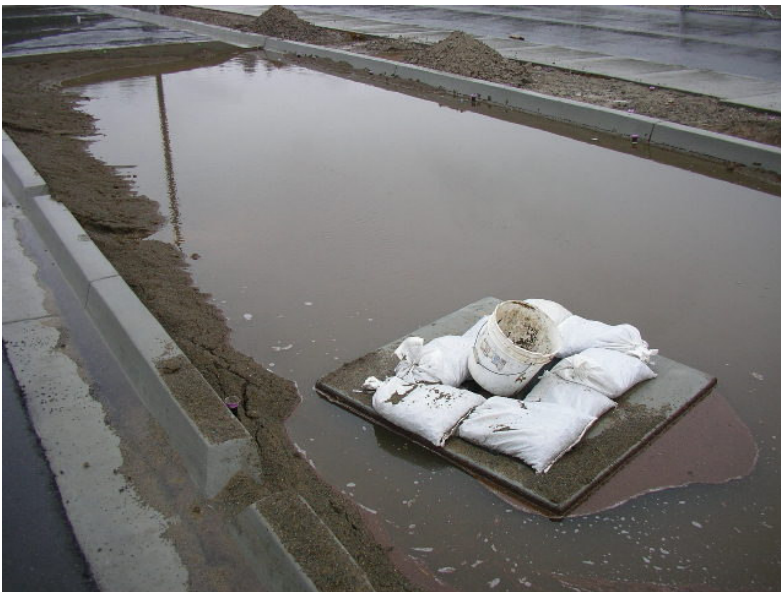
700. Storm drain inlet has been protected. This was in response to deficiencies noted on Tuesday, November 27, 2007.

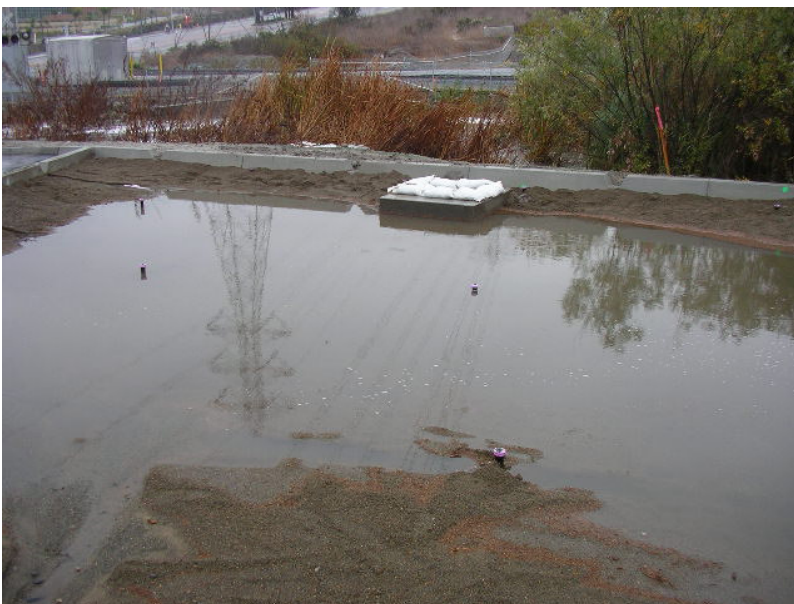
701. Storm drain inlet has been protected. This was in response to deficiencies noted on Tuesday, November 27, 2007.

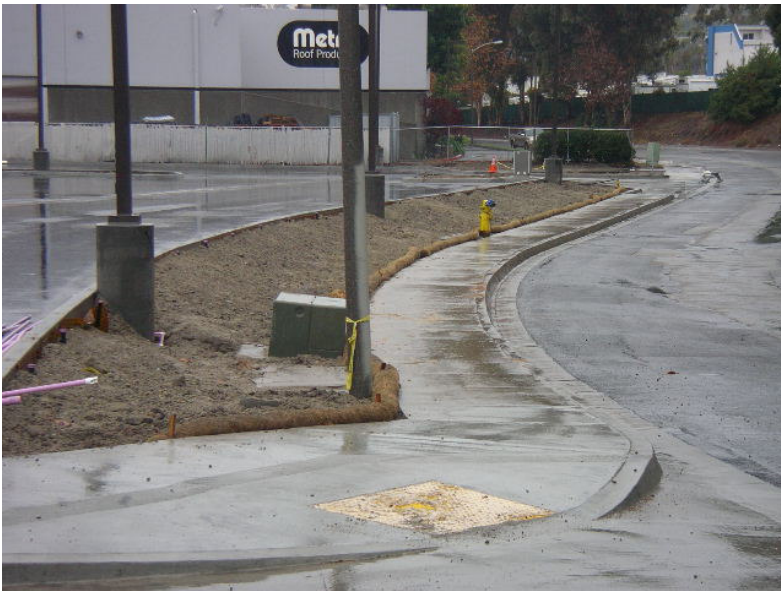
705. Fiber roll has been implemented behind the sidewalk. This was in response to deficiencies noted on November 27, 2007.

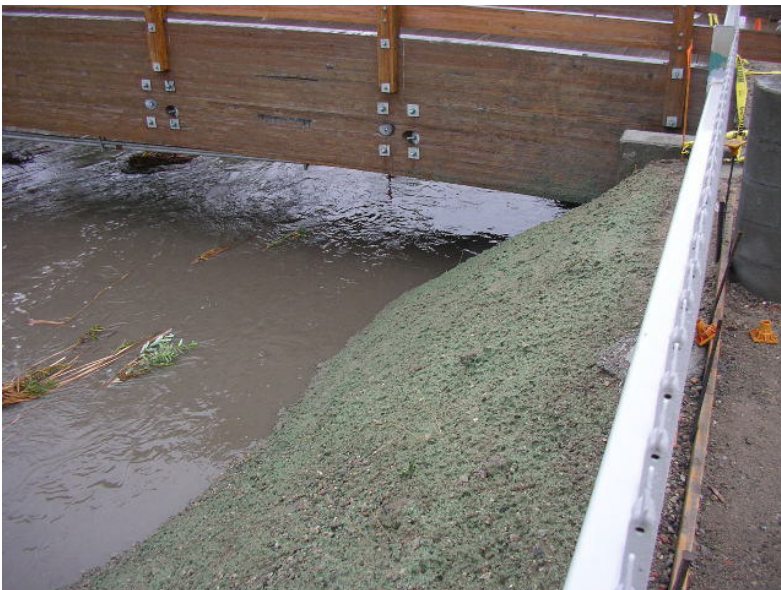
706. Erosion control has been sprayed on the banks of Loma Alta Creek near the pedestrian bridge. This was in response to deficiencies noted on Tuesday, November 27, 2007. The application looked light.

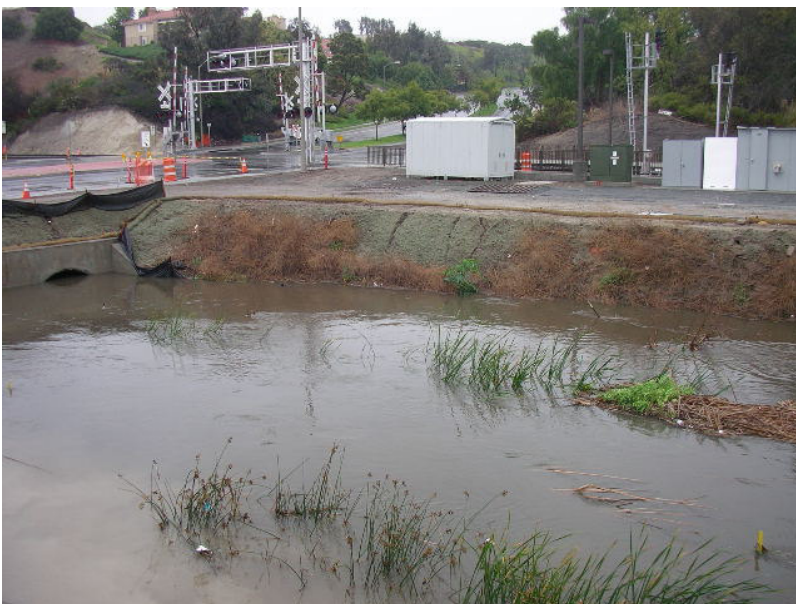
707. The bank of Loma Alta Creek has been sprayed. This was in response to deficiencies noted on Tuesday, November 27, 2007. The application appeared light.

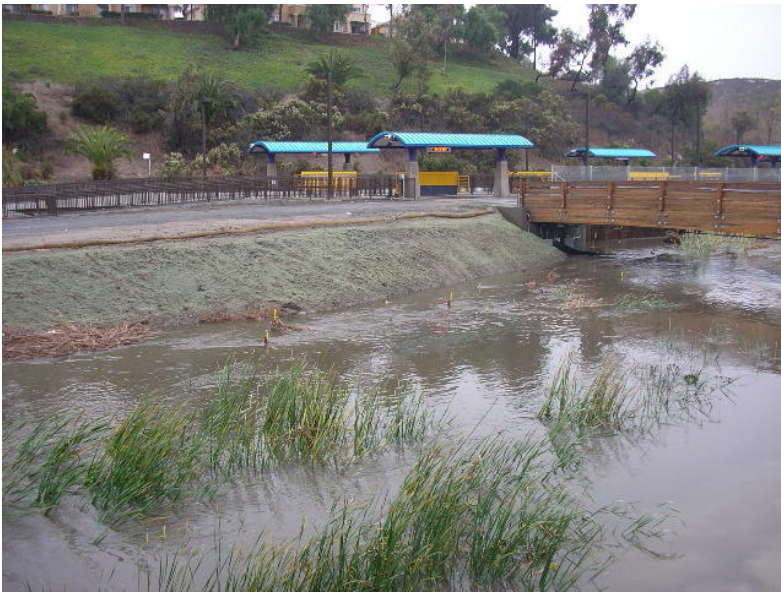
708. The bank of Loma Alta Creek has been sprayed with erosion control. The application appeared to be light. This was in response to deficiencies noted on Tuesday, November 27, 2007.

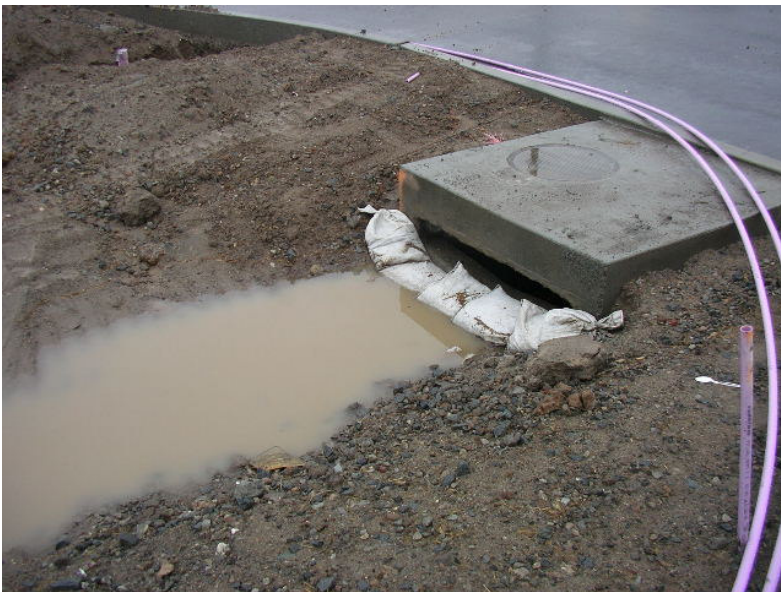
709. A storm drain inlet that appears to have been overtopped earlier in the day due to the sediment present on top of the gravel bags.

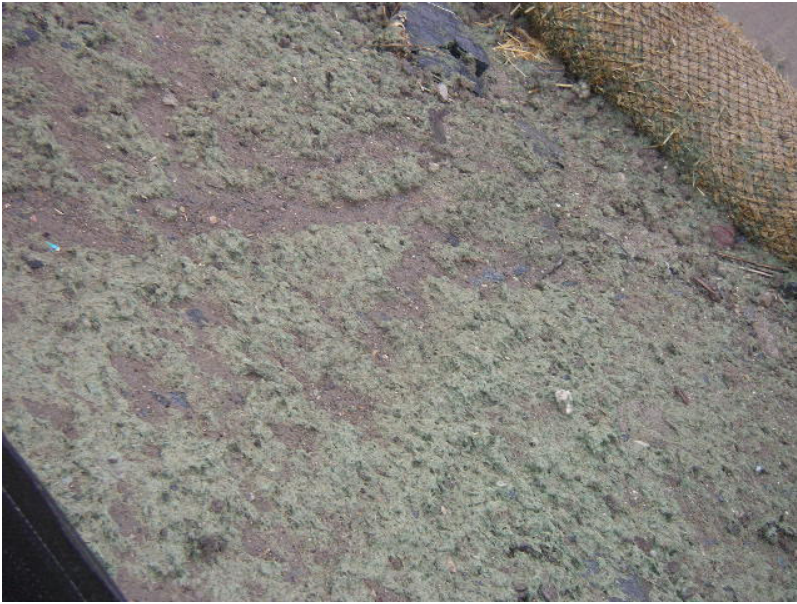
712. A closer look at the erosion control on the banks shows the inconsistent application.

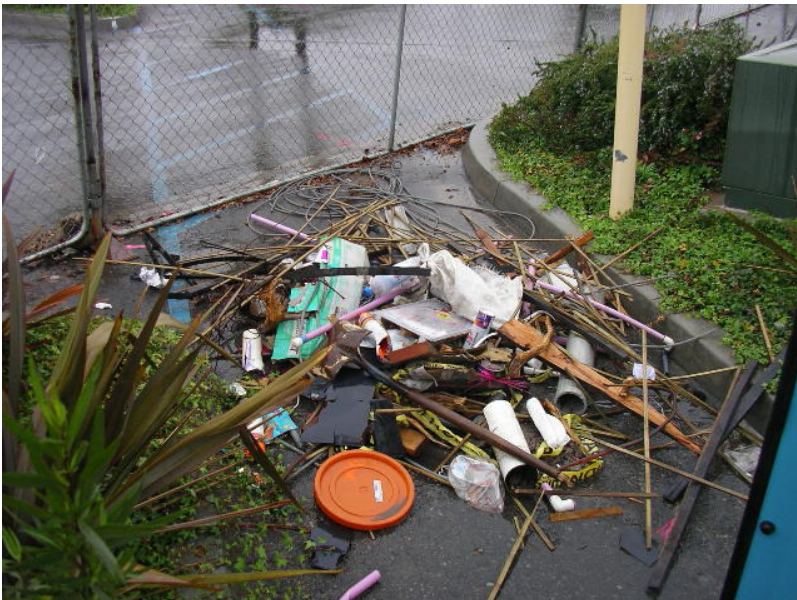
713. Construction trash left exposed to storm water.

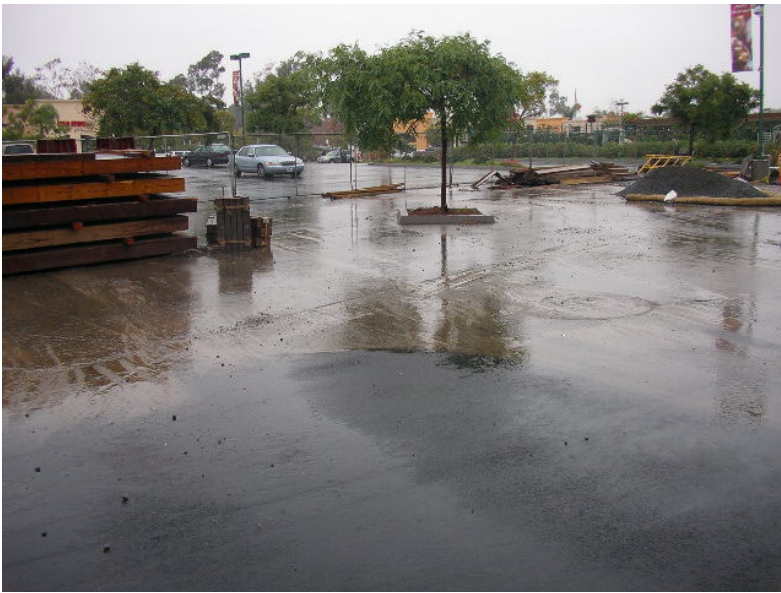
715. Sediment has not been swept up prior to rainfall on a parking lot used as a staging area for construction.

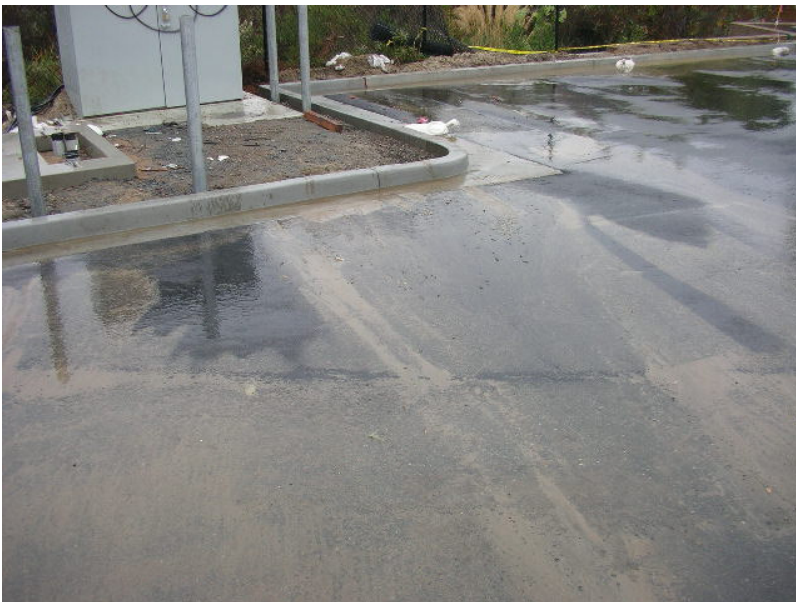
716. Another look at sediment on the parking lot that has not been swept up.

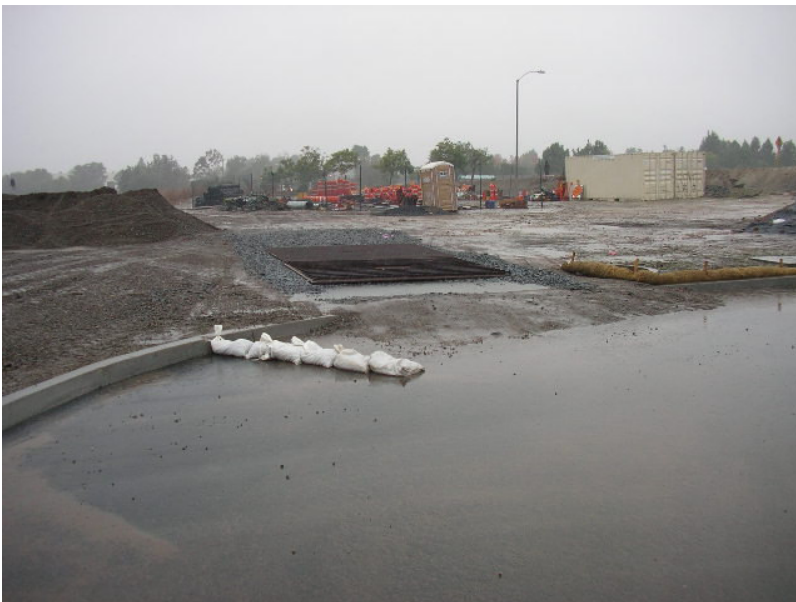
719. Gravel bag chevron has been deployed. Shaker plates and rock has been implemented at the construction exit. This was in response to deficiency noted on Tuesday, Nov. 27, 2007.

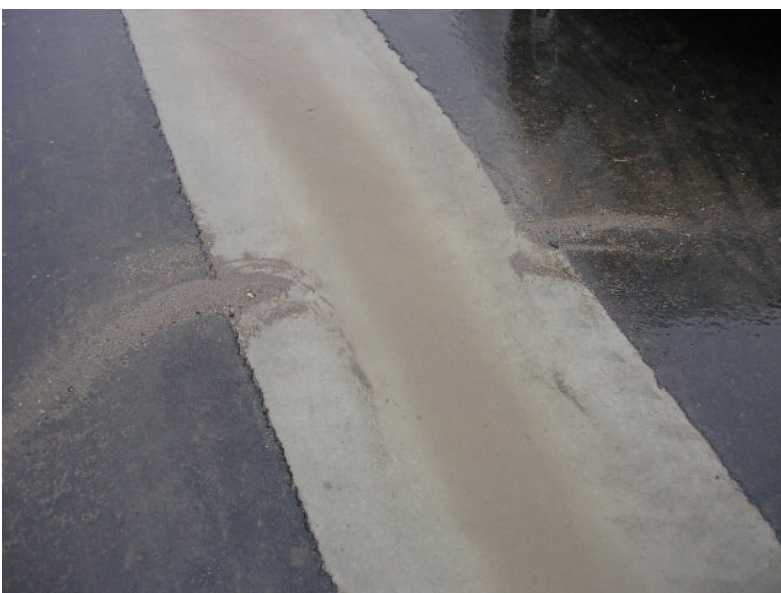
720. Sediment laden storm water in the parking lot drainage swale.

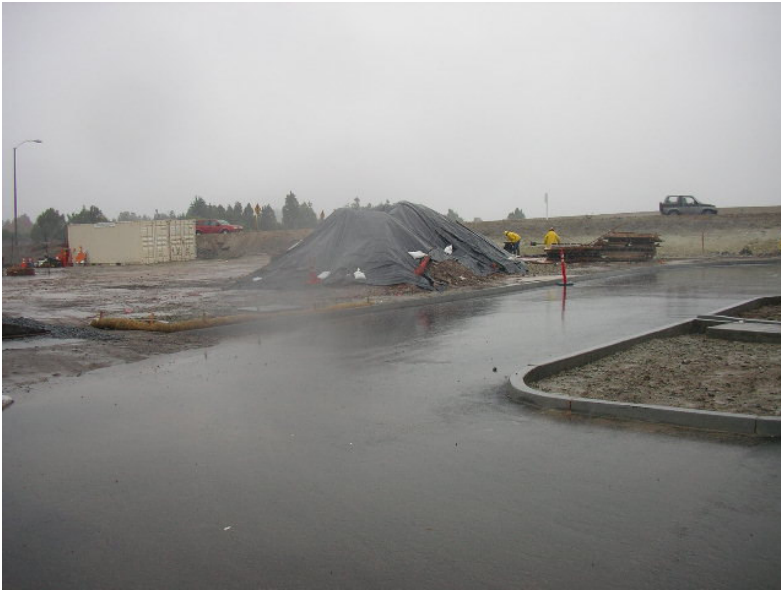
721. Soil stockpile has been covered. This was in response to deficiency noted on Tuesday, November 27, 2007.

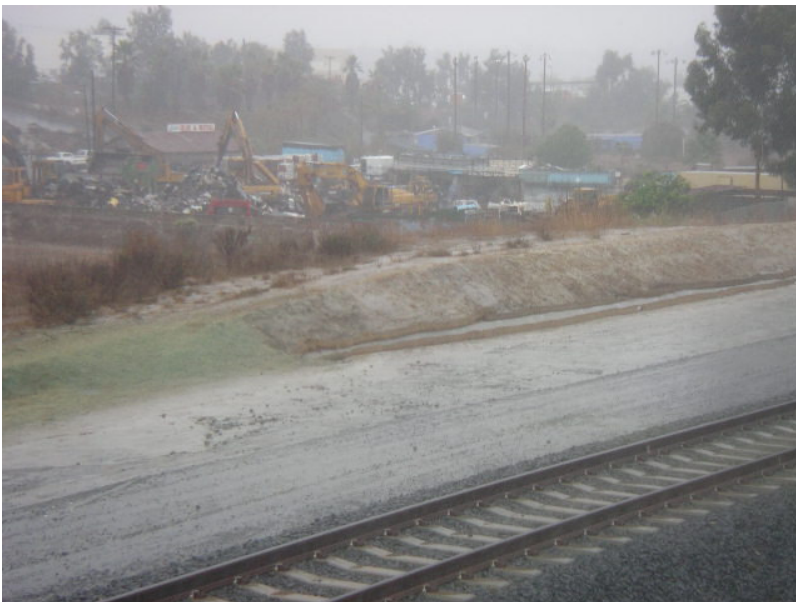
722. Erosion control stops along this slope.

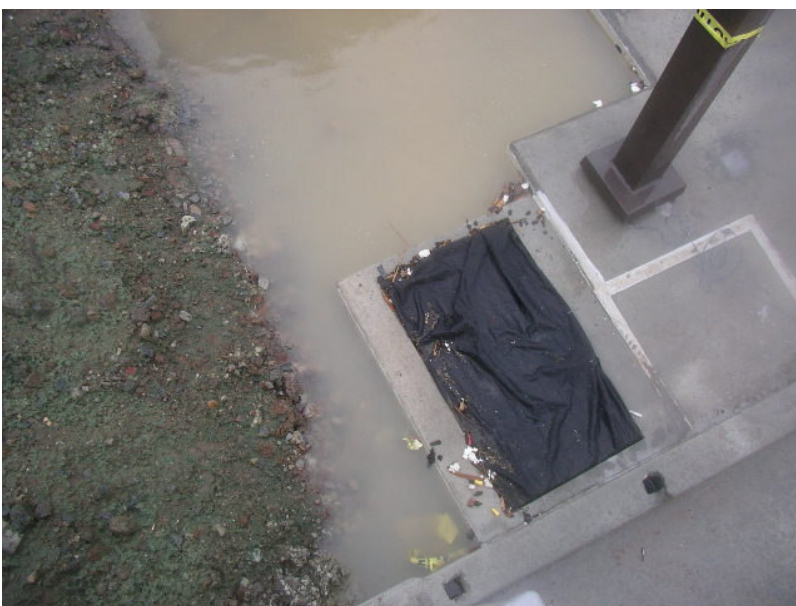
723. Storm drain inlet has been protected with filter fabric. This was in response to deficiency noted on Tuesday, Nov. 27, 2007.

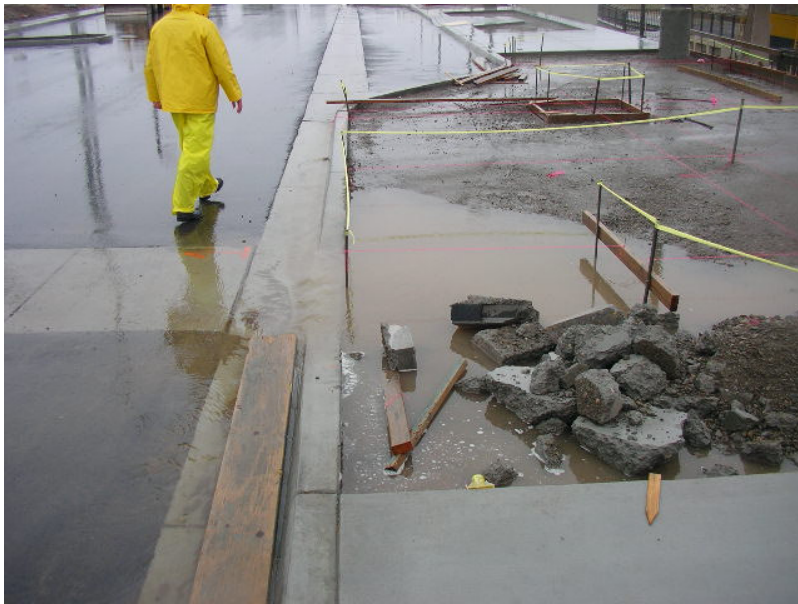
724. Source of sediment entering storm water in photo 720.

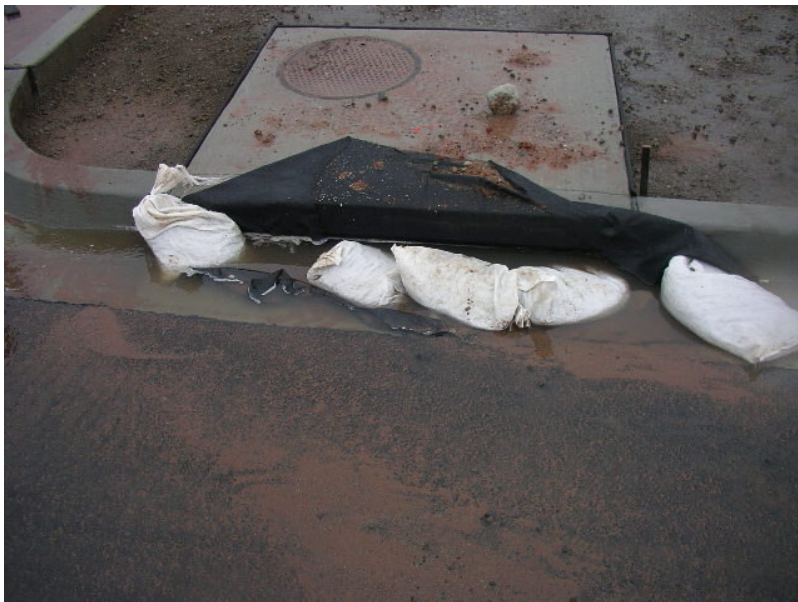
725. Storm drain inlet in need of maintenance.

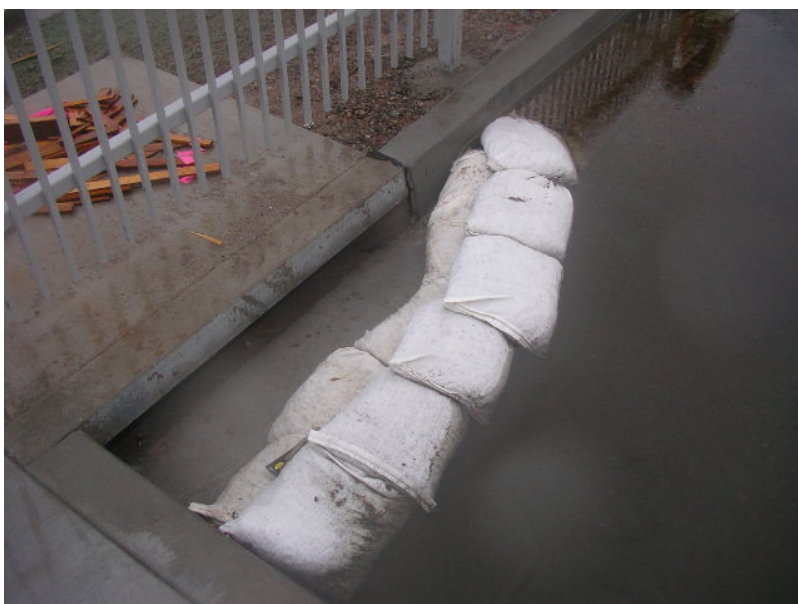
726. A protected storm drain inlet.

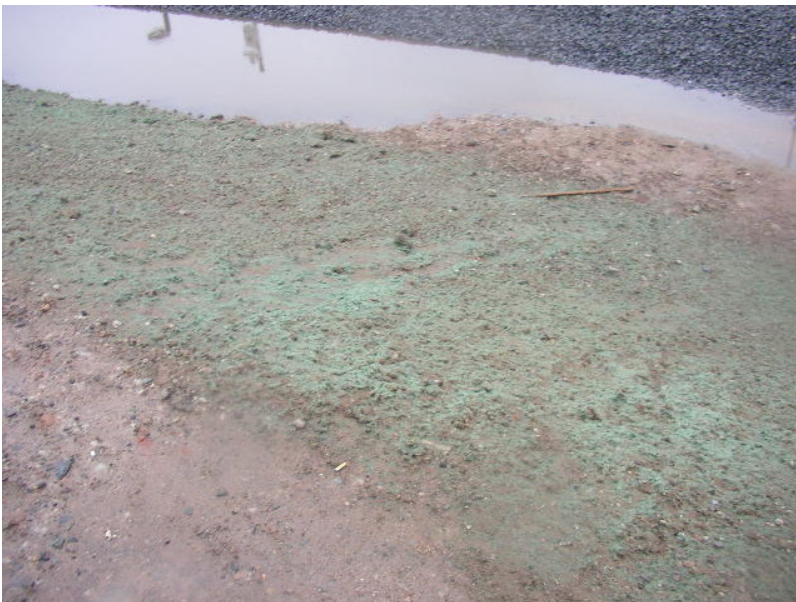
728. Erosion control sprayed along the slope is a light application.

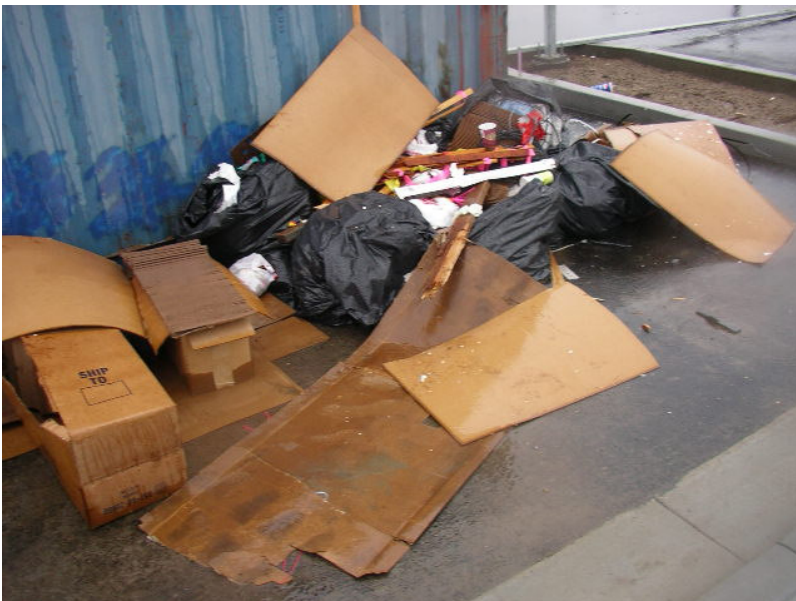
729. Construction trash left out exposed to storm water.

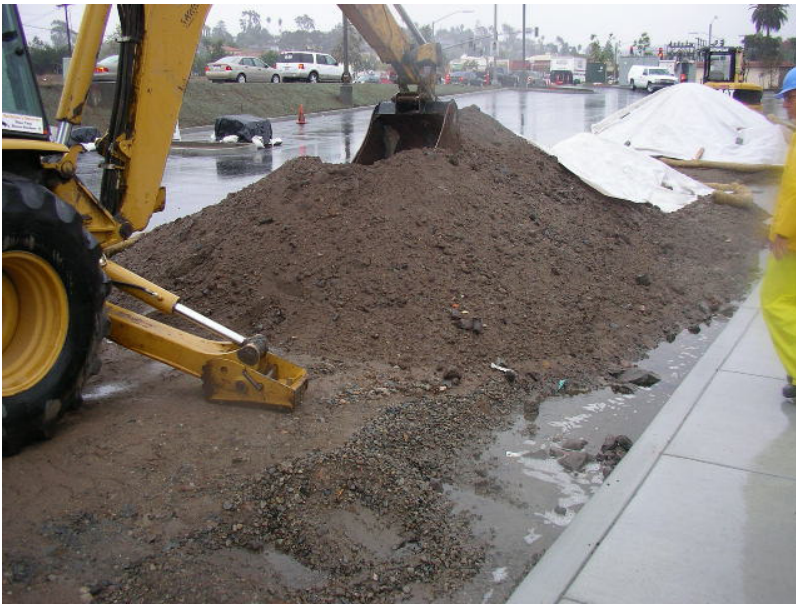
730. Soil stockpile is not covered or protected from storm water.

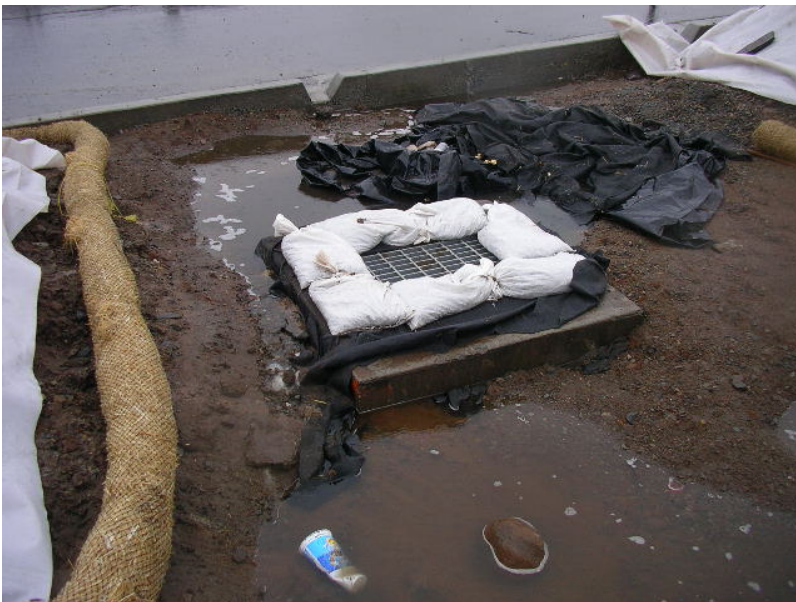
731. Storm drain inlet is protected.

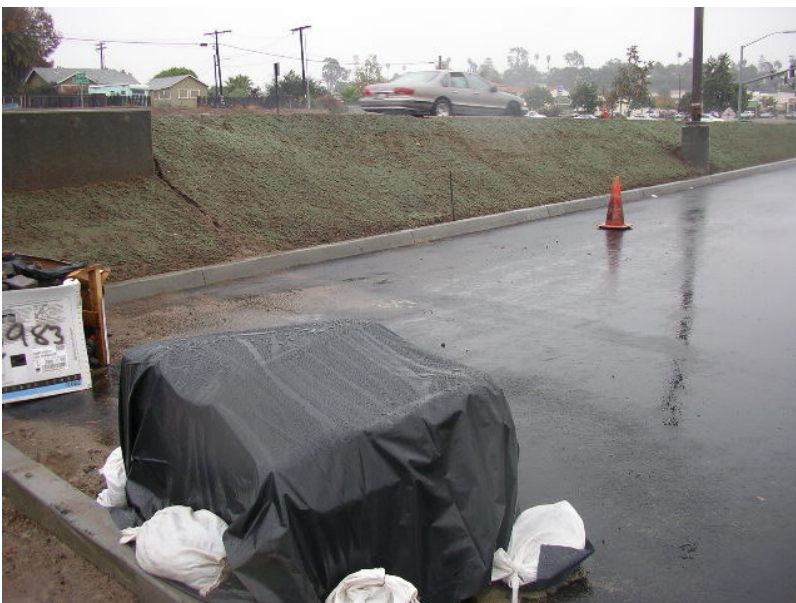
732. Construction materials are covered. The slope is sprayed with erosion control.

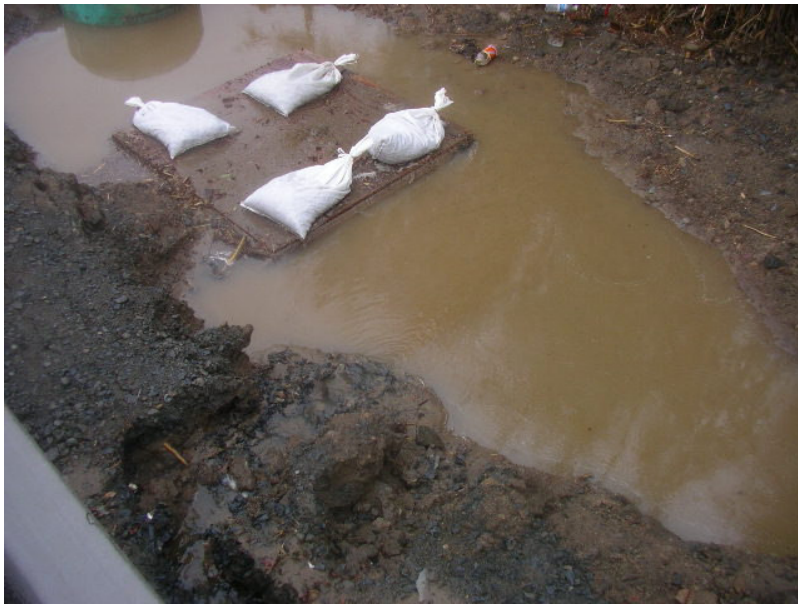
733. Storm drain inlet is covered with filter fabric. Additional protections are needed.

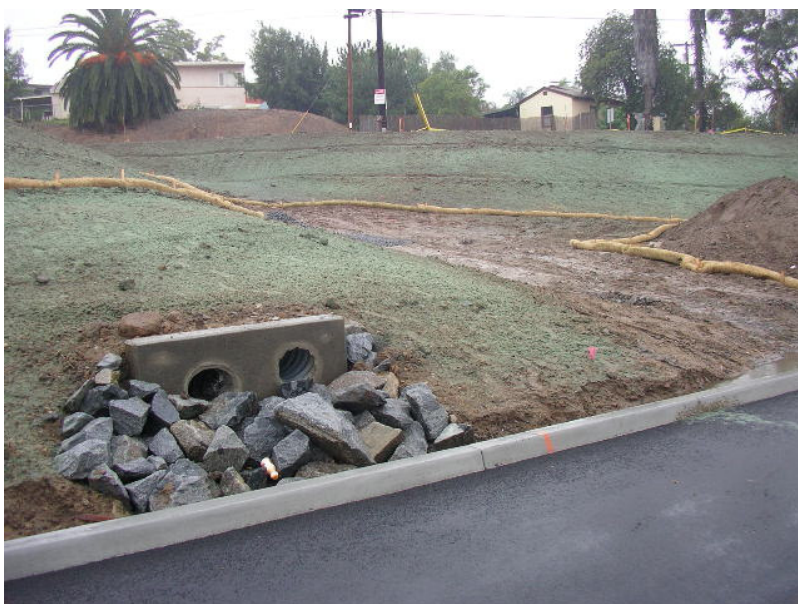
735. Slopes around the station have been sprayed with erosion control and fiber roll was implemented.

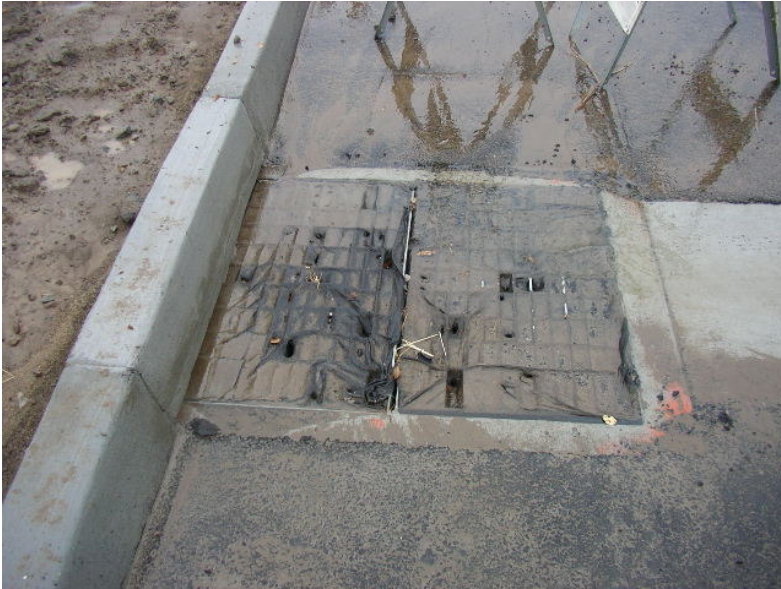
736. Filter fabric alone failed as storm drain inlet protection.
